**I-405 Congestion Relief and
Bus Rapid Transit Projects
Kirkland Nickel Project**

**I-405, SR-520 to SR-522 Stage 1
Draft Stormwater Infiltration Report**

**Geotechnical Report
I-405 Stormwater Infiltration
Kirkland Project
Kirkland, Washington**

January 17, 2005

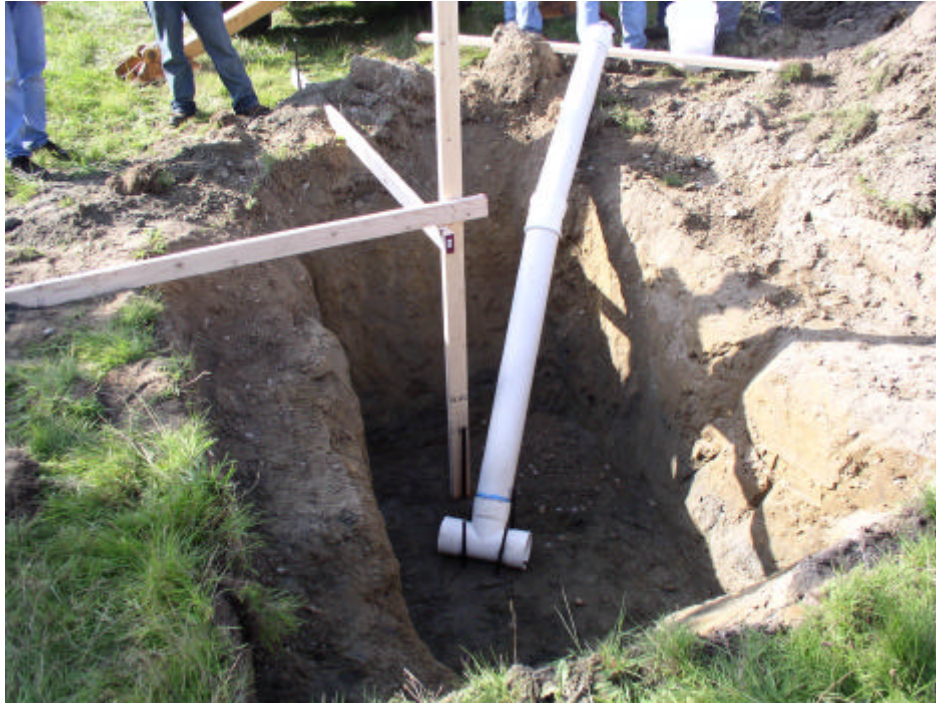
Figure 5 - Set up at PIT 1

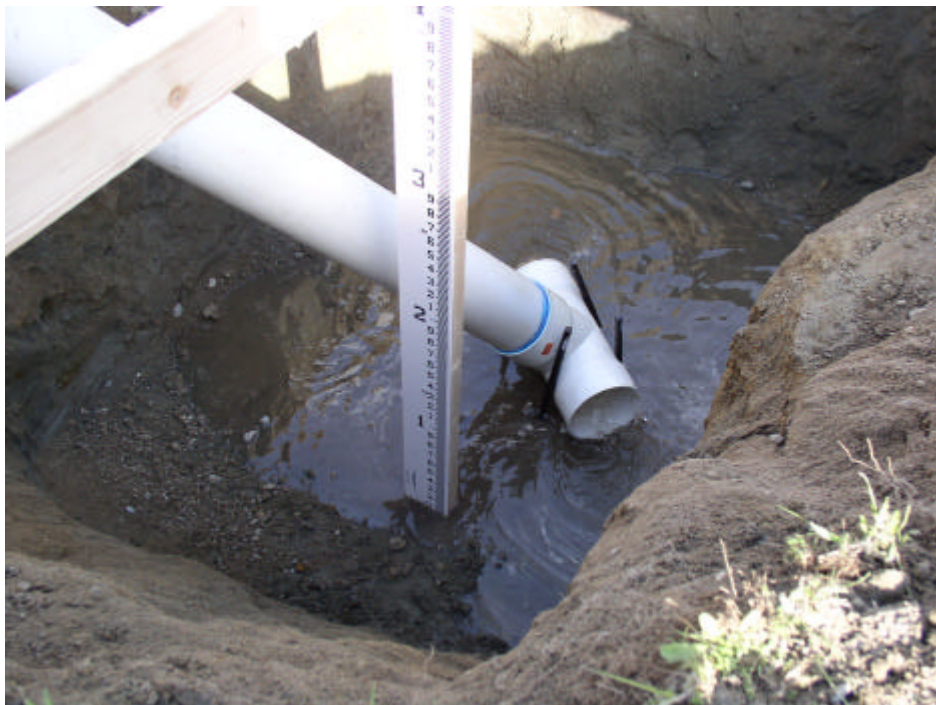
After cleaning of the loose soil from the pit bottom, the instrumentation was installed and the pit was filled with water to a depth of approximately 3.5 ft above the pit bottom. Approximately one hour was necessary to fill the pit with water. Water was continually added to the pit to maintain a constant water level of about 3.5 to 3.6 ft above the pit bottom. After about 2½ hours, the measured flow rate of water into the pit was relatively constant at approximately 0.50 gallons per minute (gpm). The water was shut off and the water in the pit was allowed to infiltrate. The water depth was approximately 3.58 ft when the water was shut off. Based on the procedure described in Appendix V-B of the WDOE 2001 Stormwater Manual (WDOE 2001), the short-term insitu field infiltration rate would be approximately 2 inches per hour (0.5 gpm/22.8 ft²).

Figure 6 - PIT 1 Filling With Water

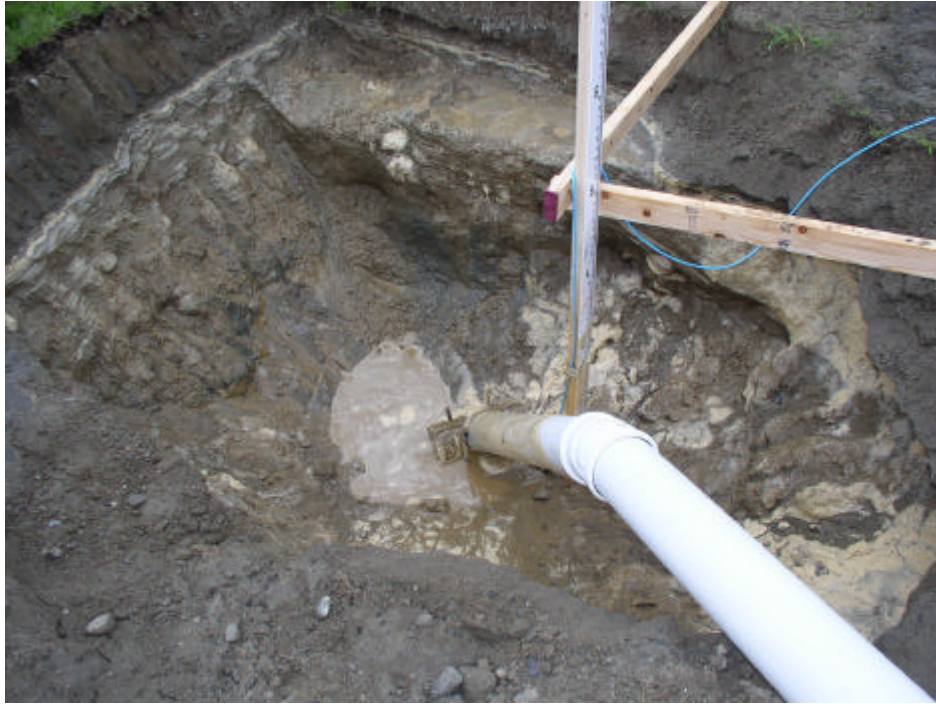
Review of the field data indicates that the 2-inches per hour rate (as calculated by the steady flow/pond bottom) is representative of water infiltrating laterally into the soil at a very shallow depth. Once the water was shut off, the water level in the pit dropped at an average rate of about 1/4 inch per hour over the first four hours of the test. Over the remainder of the test, the rate at which the water

dropped in the pit slowly declined to an average of about 0.13 inches per hour. It is our opinion that the 0.25 inch per hour rate is more representative of the actual insitu infiltration rate for a pond with a bottom at 5 ft. Therefore, we recommend that the insitu infiltration rate be 0.25 inches per hour.

In our opinion, infiltration at Site 1 is likely not feasible. The soil exposed at the planned infiltration pond bottom consists of medium dense sand with silt. Native soil of this type is generally amenable for infiltration, but the soil consists of compacted fill. It has been our past experience that insitu infiltration rates of compacted fill materials can be as much as 1 to 2 orders of magnitude less than a natural soil deposit of the same soil type. There appears to be no advantage in deepening the infiltration pond bottom to reach native soil. The explorations indicate that soil conditions become siltier with depth, and groundwater was present in the boring (KQ-1-04) below a depth of about 12½ ft.

Figure 7 - PIT 1 After Draining

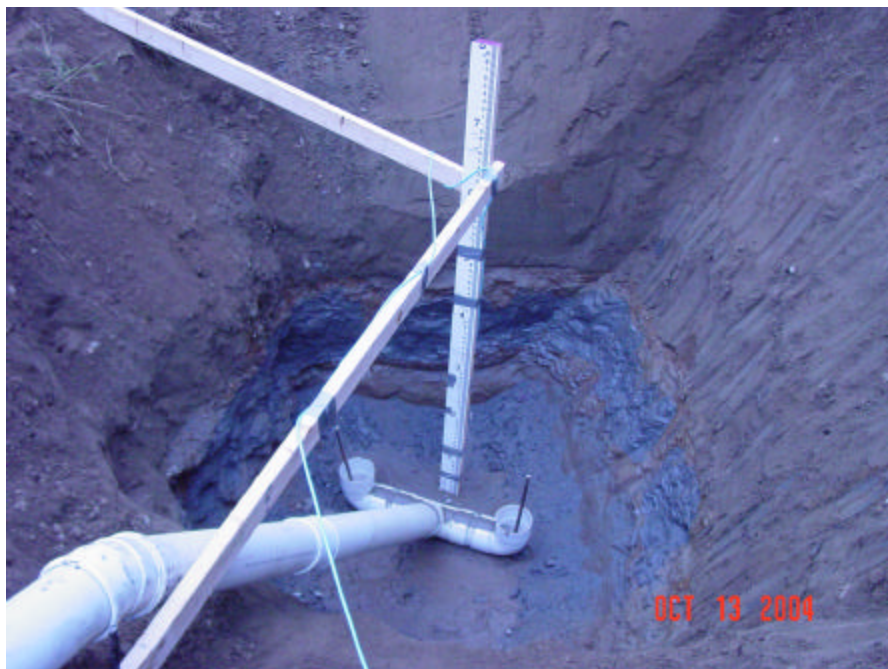
In our opinion, infiltration of stormwater at Site 2 is feasible. Based on the results of the test, we recommend an insitu infiltration rate corresponding to the initial short-term infiltration rate of 16 inches per hour. Appropriate correction factors, listed in Table 3.9 of the WDOE 2001 Stormwater Manual (WDOE 2001), need to be applied to the insitu infiltration rate to account for site variability and long-term operating conditions. We understand that the proposed facility will be an infiltration trench, which is a long, linear feature. Only two test pits were excavated to characterize soil and groundwater conditions for this study. At this time, there is insufficient data to determine if the conditions observed in the two test pits are representative of actual conditions along the proposed infiltration trench. Considerable site variability is possible along the length of the trench. Of particular concern is the 2-ft thick silt layer that was encountered in the PIT 2 excavation (test pit TP-2B) at a depth of about 4 ft, and in test pit TP-2A, excavated about 35 ft south of the PIT 2 test, at a depth of about 5 ft. If present below the bottom of the infiltration trench, the silt will act as an aquitard, generally inhibiting infiltration. Also, groundwater may become perched on the silt layer during the winter/spring months, further inhibiting infiltration. The silt layer may be present at variable depth and extend (horizontally and vertically) over

the length of the proposed bioswale/infiltration trench. If present, near the bottom of the infiltration trench, the silt layer will generally inhibit infiltration.

Figure 8 – PIT 2 After Draining – Note Silt Layer (Blue) on Wall

To address the uncertainty in soil conditions, we recommend that additional test pits/borings be completed about every 50 to 75 ft along the length of the bioswale/infiltration trench to investigate if the silt layer is present, and if present, at what depth. The excavations should penetrate at least 5 ft below the proposed bottom of the infiltration trench. Representative soil samples of the soil below the base of the proposed trench should be obtained from the explorations and tested to determine the USDA soil textural classification. The results of the soil test should be compared to grain-size analyses of soil samples tested for this investigation. If conditions in the additional explorations are similar to conditions observed in the test pits excavated for this study, then the site variability correction factor could be reduced. If conditions are substantially different, then additional insitu infiltration testing may be warranted.

If the additional explorations indicate that the silt layer is present within a depth of about 5 ft below the infiltration trench bottom, the layer should be overexcavated. The overexcavation should be backfilled with a free-draining material, such as Gravel Backfill for Walls meeting the gradation requirements in Section 9-03.12(2) of the 2004 WSDOT Standard Specifications (WSDOT 2004). Over compaction of the material should be avoided. We suggest compacting the material by lightly tamping with the excavator bucket.

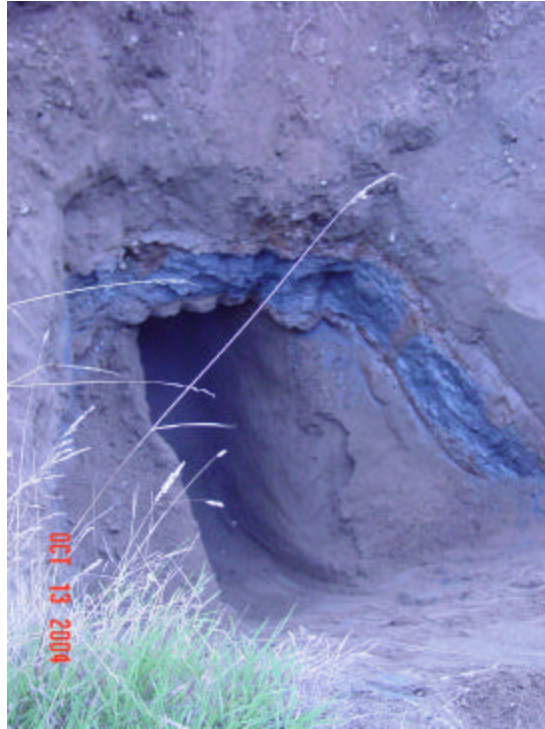
Figure 9 - Test Pit 2B. Note Silt Layer (blue) on Test Pit Wall

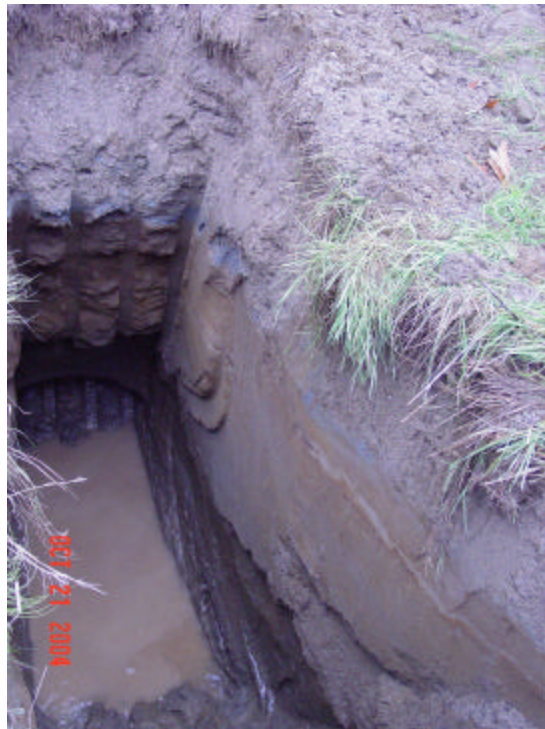
In our opinion, infiltration at Site 3 is infeasible. Three test pits, TP-3A through TP-3C, were excavated along the length of the proposed infiltration facility at Site 3. Groundwater seepage was encountered in all the test pits above the planned bottom depth of 5 ft below existing grades.

Figure 10 - Seepage in PIT 3A

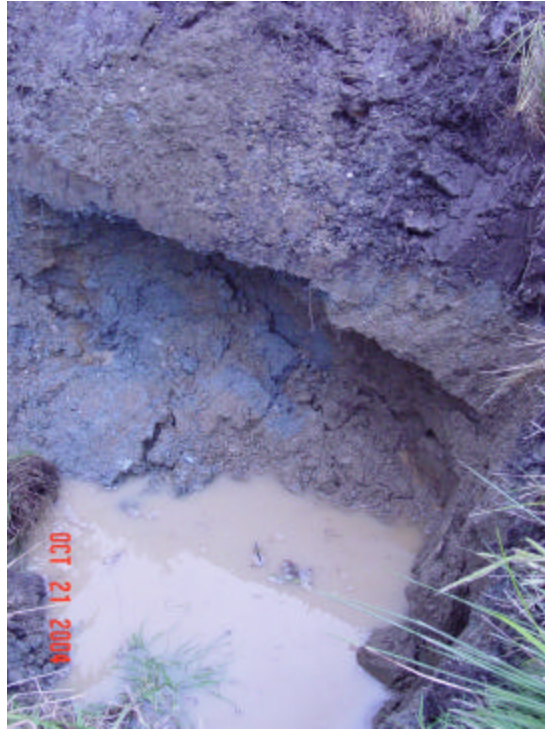
Figure 11 - Seepage in PIT 3B

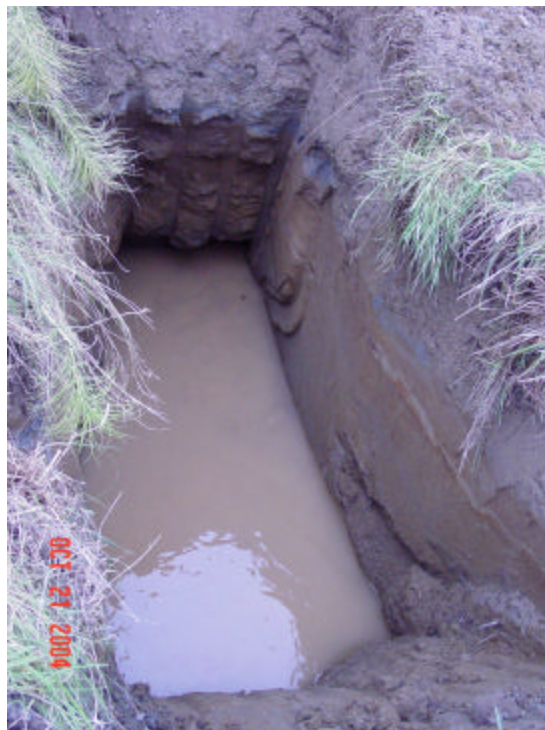
Figure 12 - Seepage at PIT 3C
